City of Temple Terrace ADA Transition Plan

Curb Ramp and Building Barrier Removal Program

THE ASH GROUP, INC.
5802 Benjamin Center Drive,
Suite 101
Tampa, FL 33634
813.290.8899

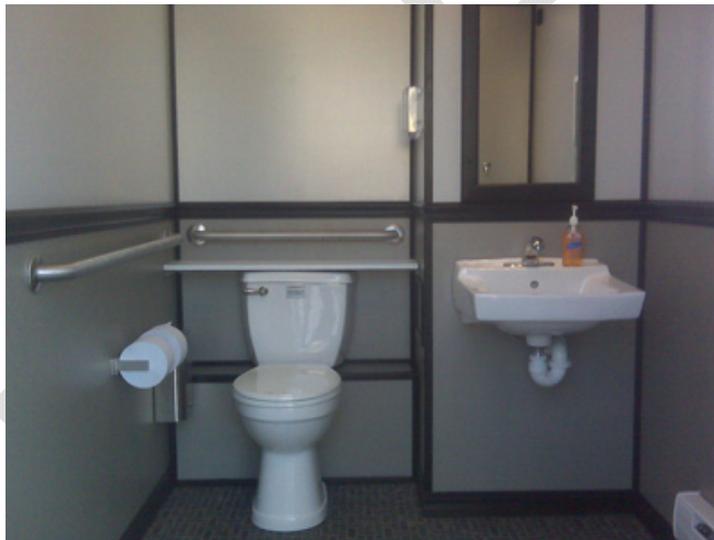
Compliant ADA Accessible Toilet Room

Most building had deficiencies in priority three, providing ADA accessible toilet rooms. Due to the age of some of the facilities, many were constructed without adequate space to provide completely ADA-compatible restrooms. See section 3.18 of the ADA checklist

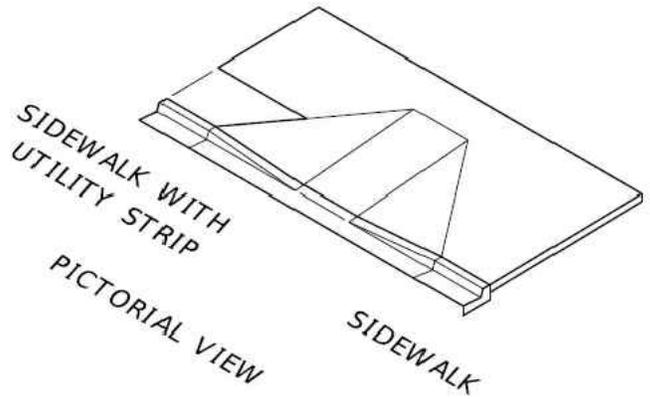
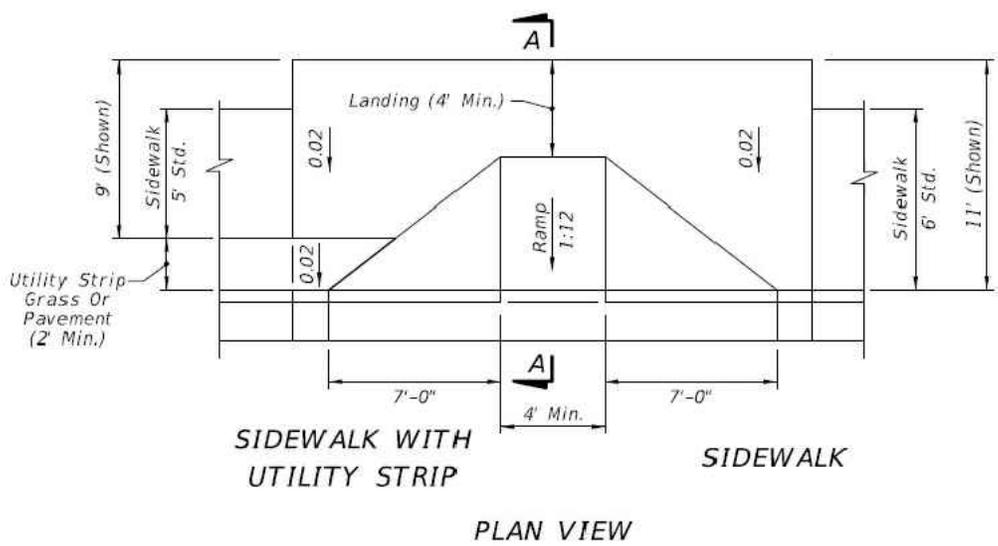
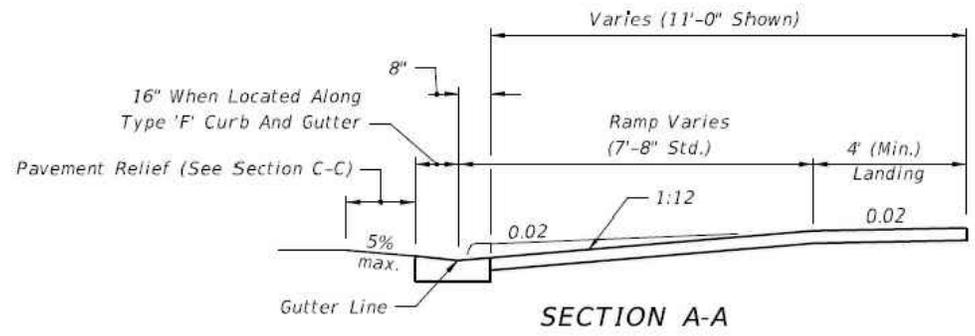
SECTION THROUGH RAMP AND LANDING
(UNRESTRICTED CONDITIONS)

Figure 2.0 is a detail of an appropriate curb ramp. Using the specifications of an acceptable curb ramp field crews were deployed to observe each intersection for the above items. Using tape measures and levels crews were able to determine ramp, running and cross slopes. Crews kept detailed notes by sketching each intersection depicting slopes and structural deficiencies, then photographing their condition. Field notes were input into the excel spread sheet attached in Appendix A – Curb Ramp Inventory.

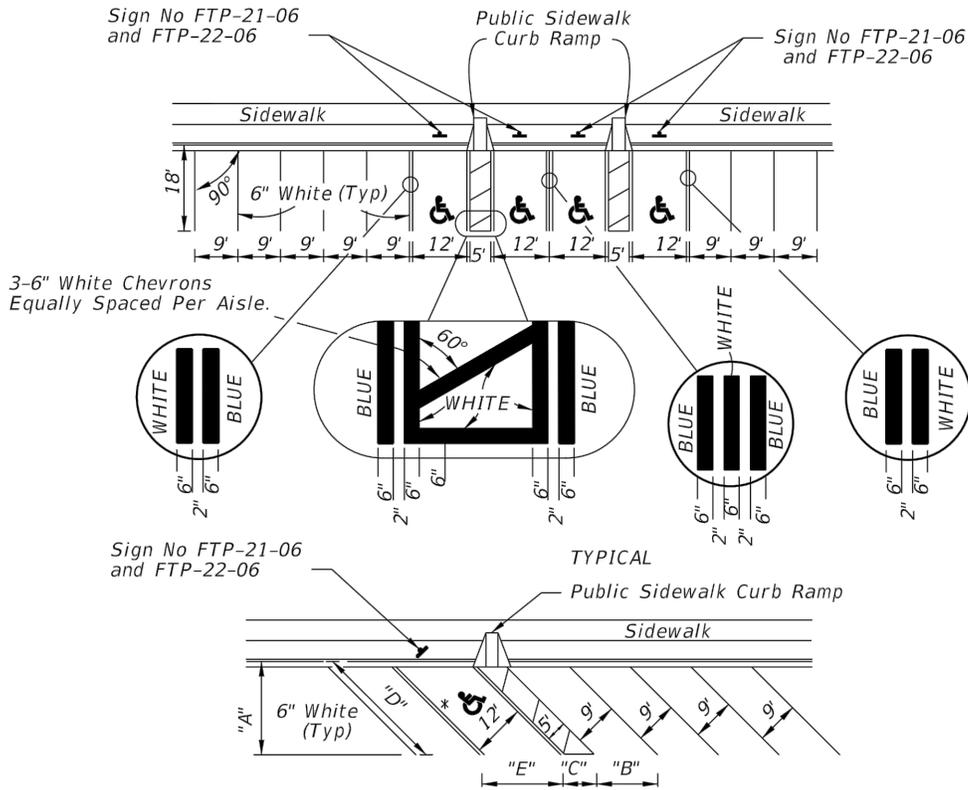
* FOR ACCESSIBLE MARKINGS - SEE ABOVE

One of the common barriers observed in priority one (approach and entry) showed that van accessible parking spaces were not available. The handicap spaces provided did not have proper width for both the space and the access isle. Standard details for appropriate parking space width are shown in Figure 4.0.

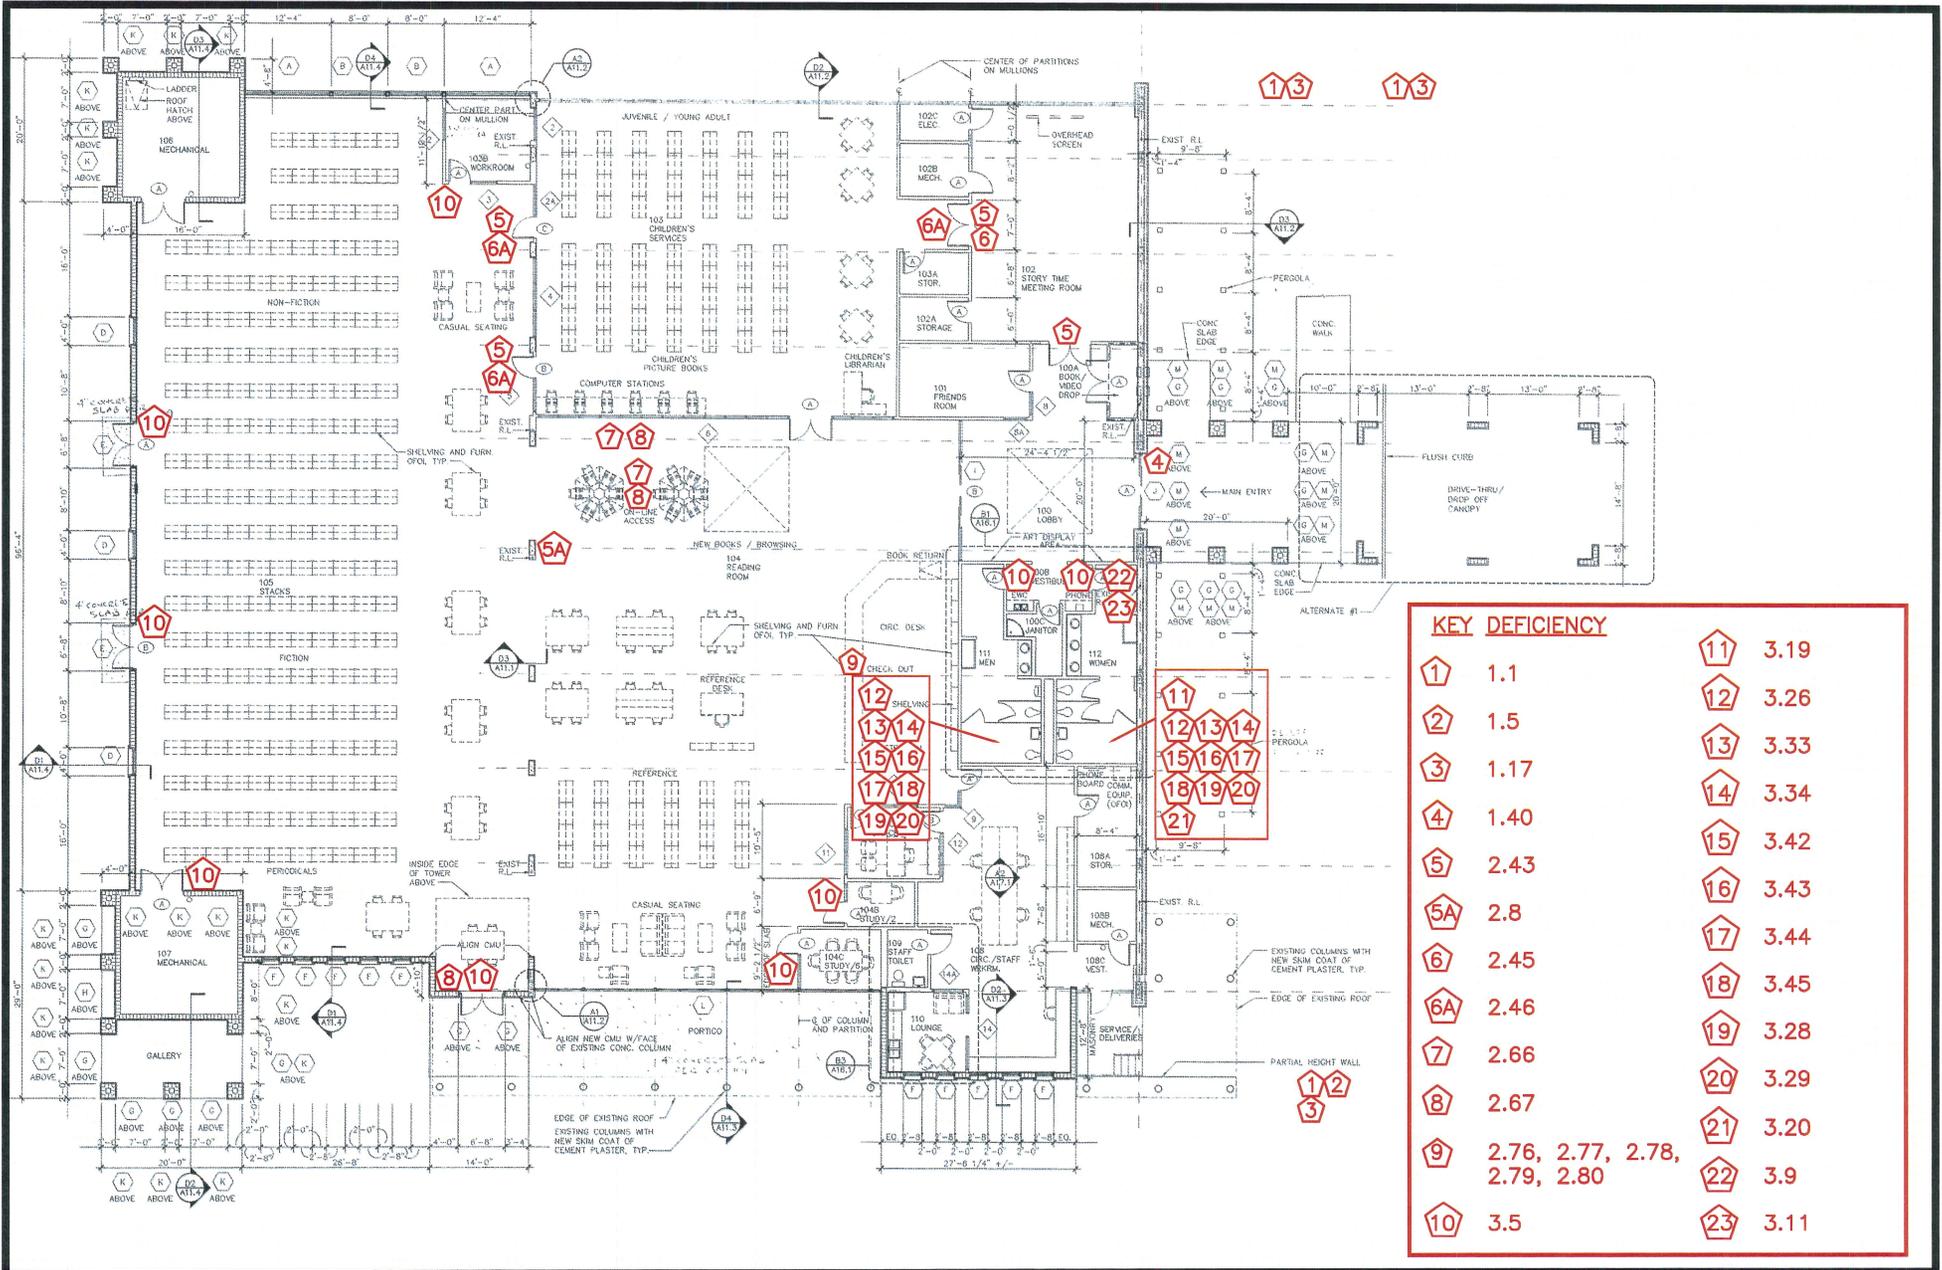
KEY DEFICIENCY	
1	1.1
2	1.5
3	1.17
4	1.40
5	2.43
5A	2.8
6	2.45
6A	2.46
7	2.66
8	2.67
9	2.76, 2.77, 2.78, 2.79, 2.80
10	3.5
11	3.19
12	3.26
13	3.33
14	3.34
15	3.42
16	3.43
17	3.44
18	3.45
19	3.28
20	3.29
21	3.20
22	3.9
23	3.11

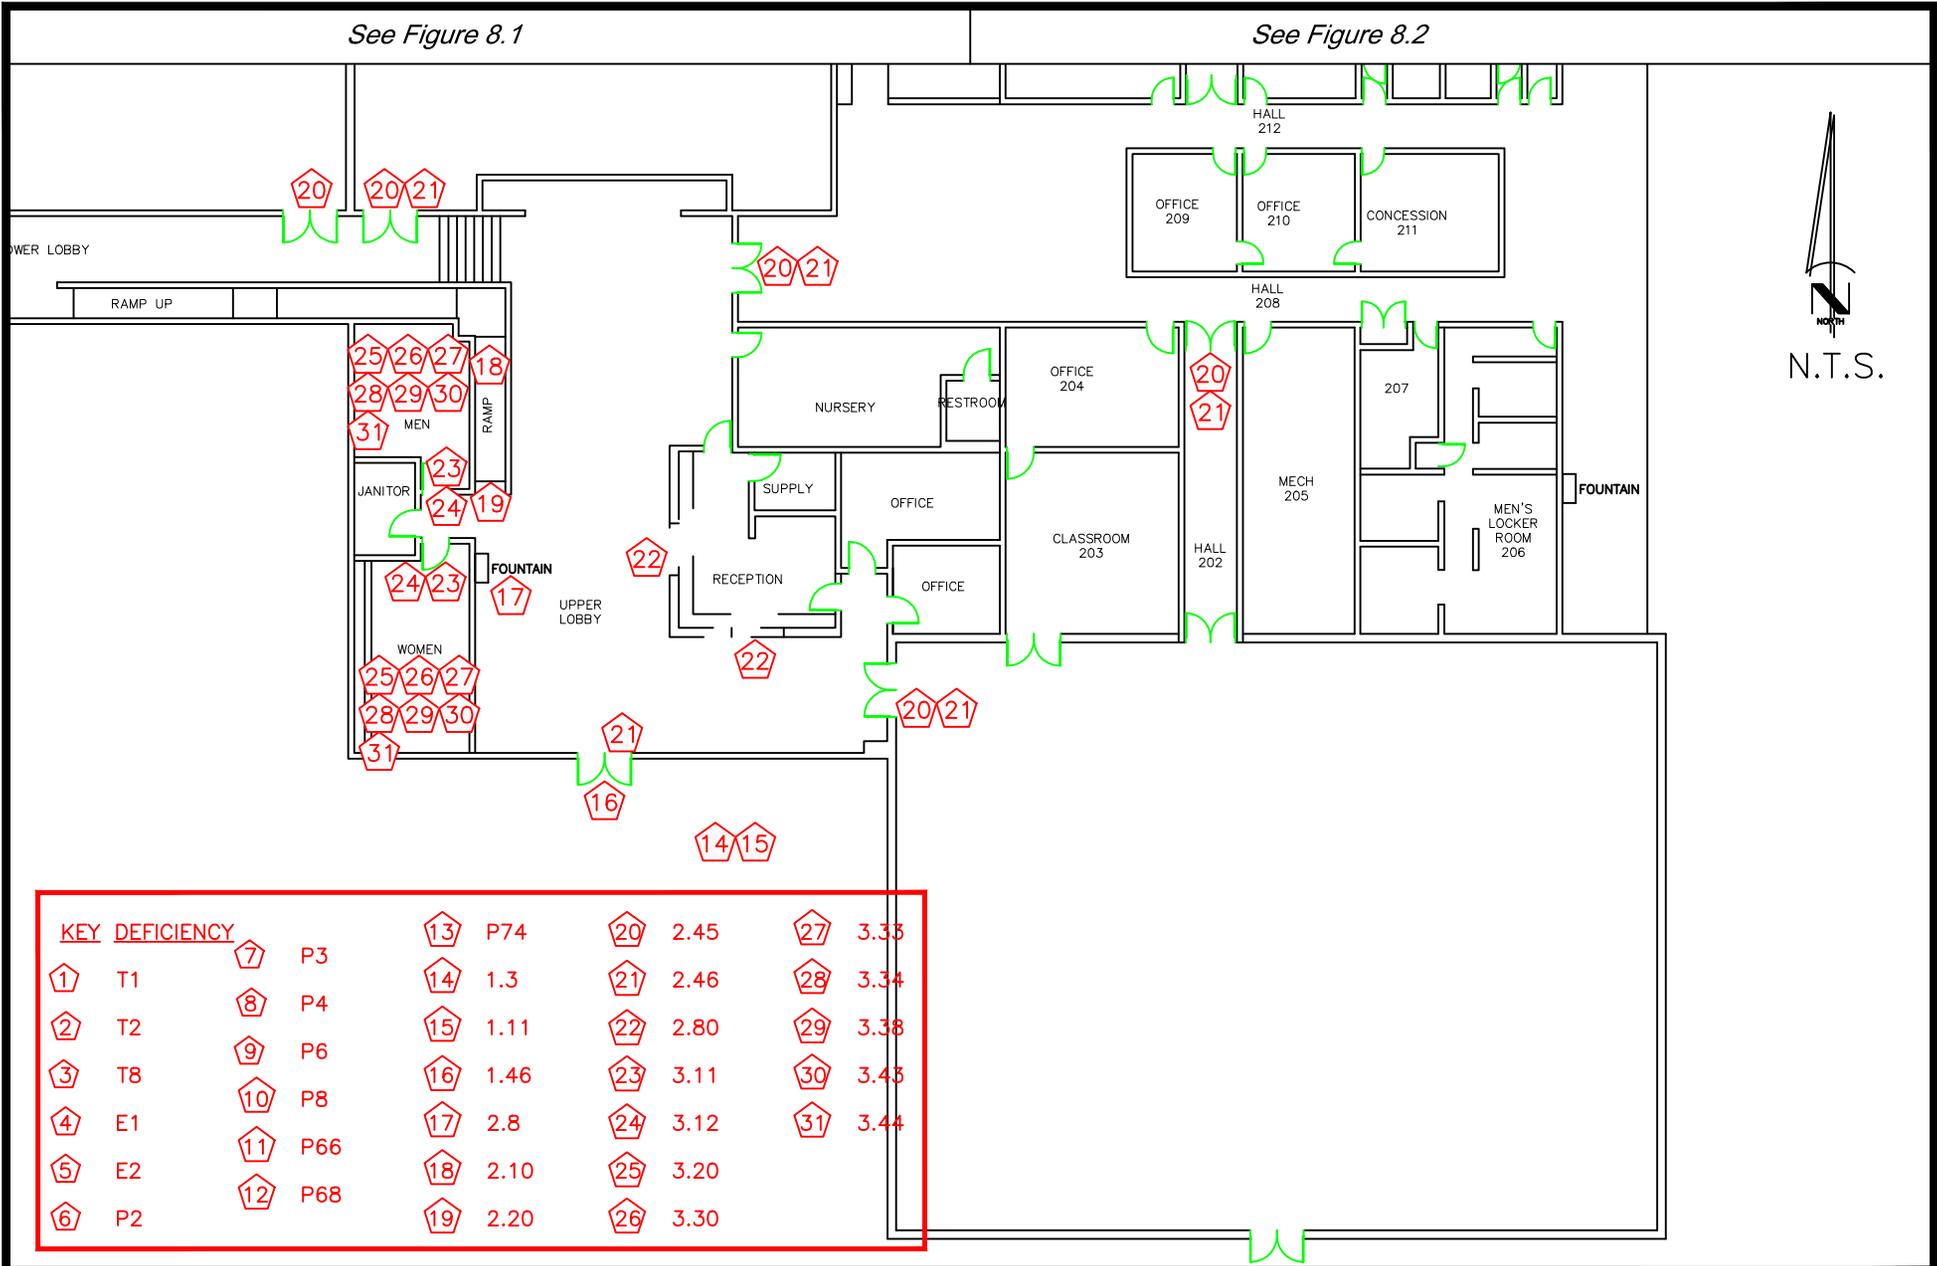
KEY DEFICIENCY					
①	T1	⑦	P3	⑬	P74
②	T2	⑧	P4	⑭	1.3
③	T8	⑨	P6	⑮	1.11
④	E1	⑩	P8	⑯	1.46
⑤	E2	⑪	P66	⑰	2.8
⑥	P2	⑫	P68	⑱	2.10
				⑲	2.20
				⑳	2.45
				㉑	2.46
				㉒	2.80
				㉓	3.11
				㉔	3.12
				㉕	3.20
				㉖	3.30
				㉗	3.33
				㉘	3.34
				㉙	3.38
				㉚	3.43
				㉛	3.44

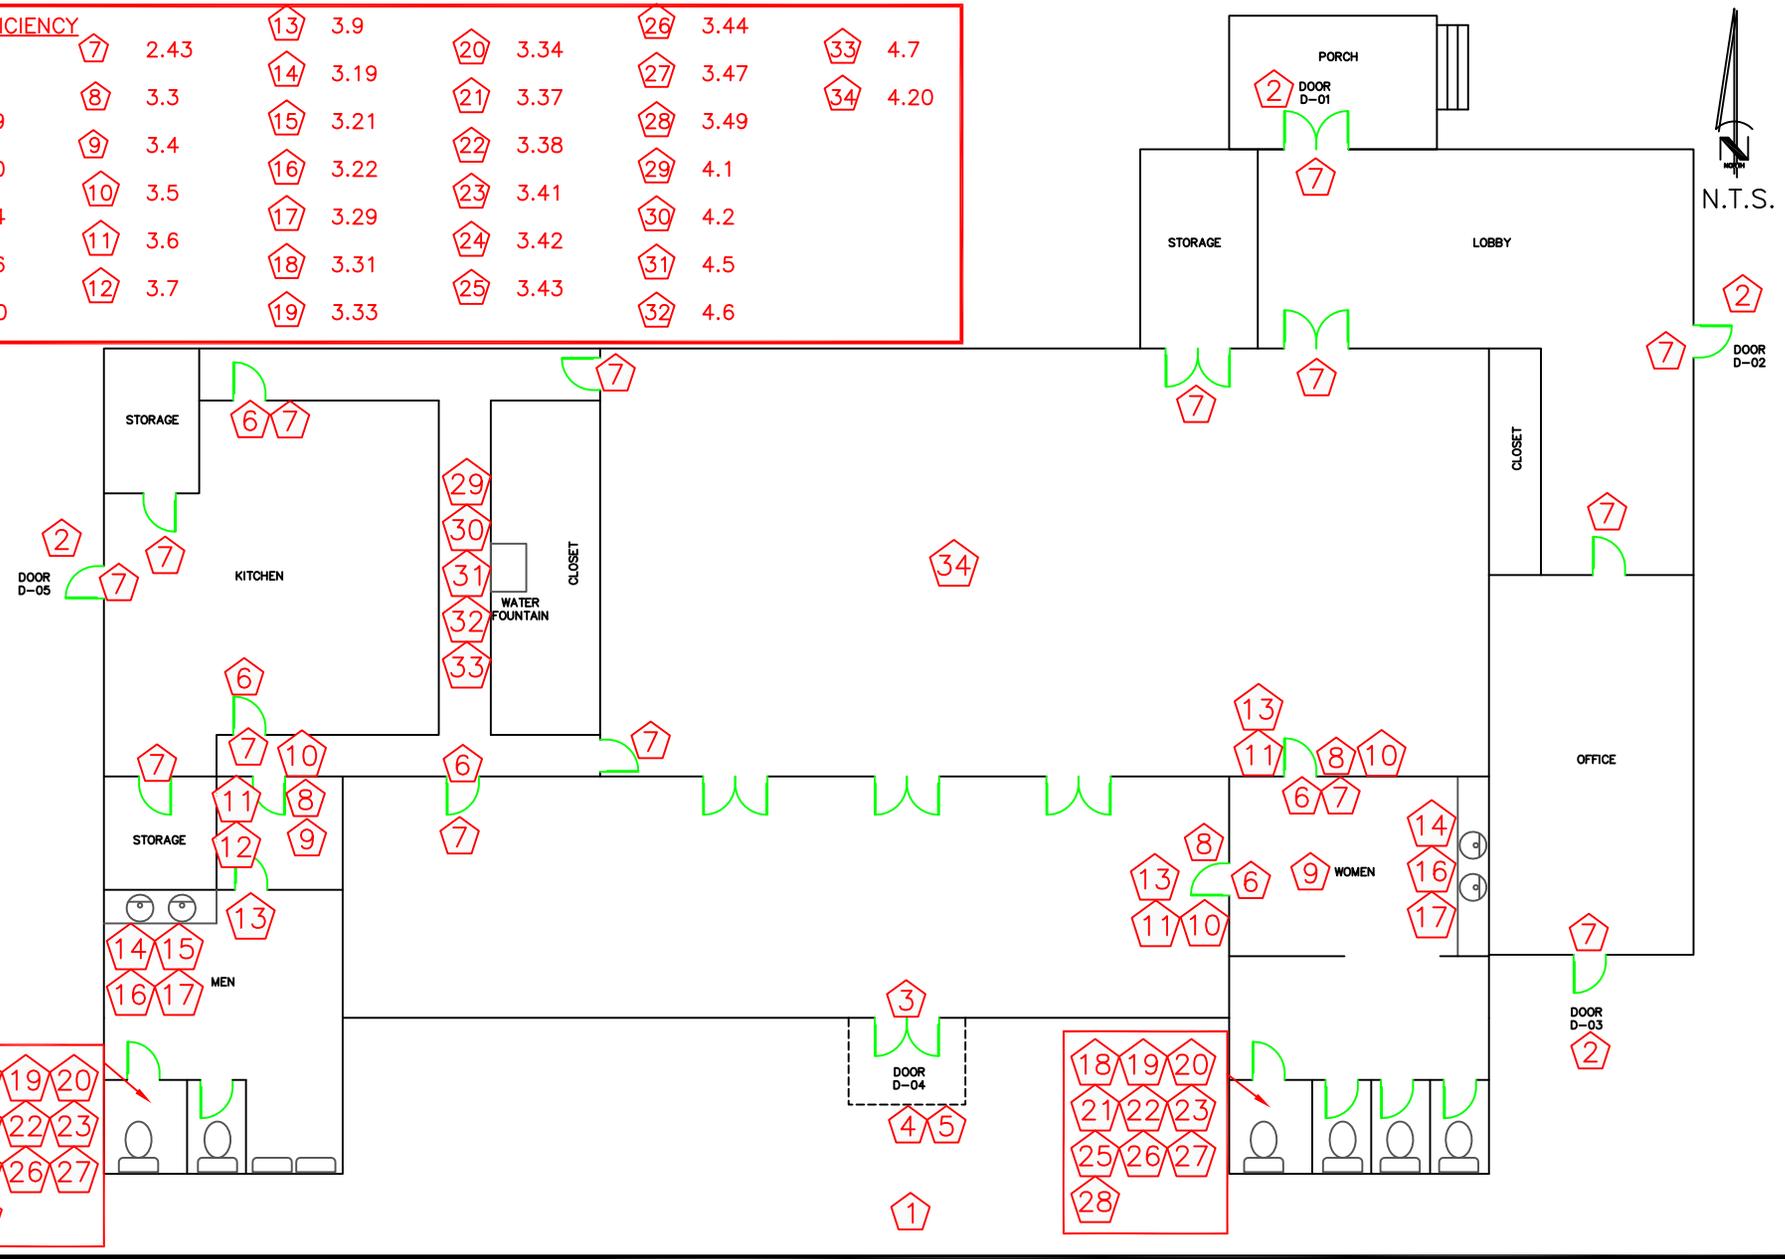
1	1.2	8	3.3	13	3.9	20	3.34	26	3.44	33	4.7
2	1.39	9	3.4	14	3.19	21	3.37	27	3.47	34	4.20
3	1.40	10	3.5	15	3.21	22	3.38	28	3.49		
4	1.44	11	3.6	16	3.22	23	3.41	29	4.1		
5	1.46	12	3.7	17	3.29	24	3.42	30	4.2		
6	2.40			18	3.31	25	3.43	31	4.5		
				19	3.33			32	4.6
